fast times

the newsletter of **Bavarian Autosport**

Summer 2008

Fast Times celebrates its 5th anniversary with "Otto's Greatest Hits, Volume One."

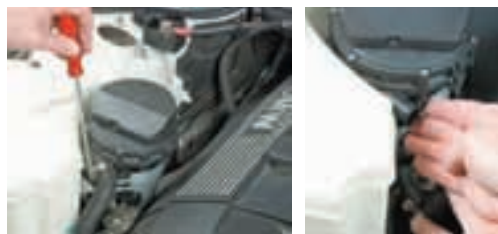
1 Is the pump running? With the engine fully cold (such as overnight or after a few hours of sitting), remove the pressure hose from the pump. (You can also remove the opposite end of the hose, from the manifold check valve, if access is easier.) Have a helper start the engine. Is the pump running and pumping air out of the outlet nipple (or the end of the hose that was removed from the valve)? If no, go to step 2; if yes, go to step 4. Note: Turn engine off as quickly as possible, in order to perform the next stage of testing while engine is still cold.

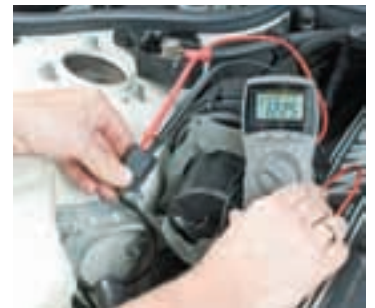
3 Test for 12 volts at the pump harness connector. With the engine fully cold, use a multimeter or 12-volt test light to check for power between the two terminals in the pump harness plug when the engine is started. (Have a helper start the engine so you can test immediately.) If yes, and the pump did run in step 2, repeat steps 1 through 3 to verify your findings; you may have made a mistake. If no, check the fuses and relay. See applicable Bentley repair manual for details and locations. In this case, they are fuses #2 (30-amp) and #3 (20-amp) in the electronics box fuse pack carrier (under hood, driver's side), fuse #36 (50-amp) in the main fuse panel (above glove box) and the relay in main relay panel (behind glove box). If you find a faulty fuse or relay, correct the fault and repeat step 3 to verify that you have power at the pump's harness connector. Repeat step 1 if the pump did run in step 2 (pump should now run). If pump did not run in step 2, we need to replace the pump and go on to diagnosing the check valve circuit. It would also be wise to diagnose the check valve circuit even if the pump now runs properly.

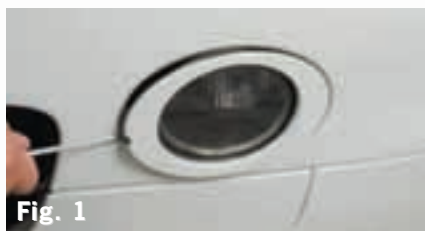
1 Pry off the trim ring (fig. 1).

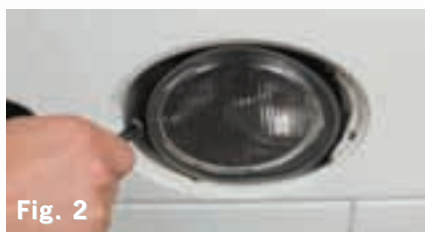
2 Remove the inboard screw (fig. 2).

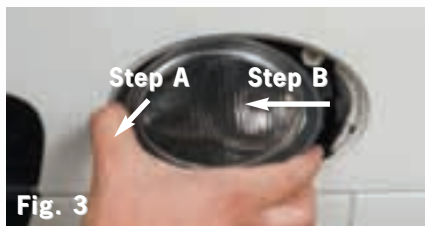
3 Step A: Pull the inboard side of the light out of bracket. Step B: pull the light off of the outboard locator pins (fig. 3).

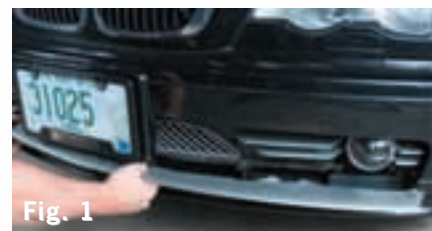
1 Unsnap/remove lower trim panel (fig. 1).

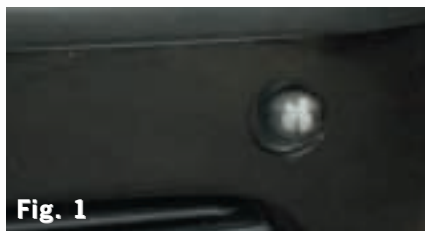
1 Access to this style fog light (fig. 1) is from behind the bumper.

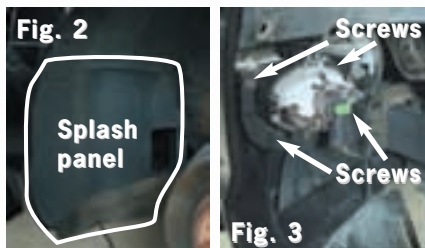
2 Remove the splash panel in front of the wheel (fig. 2), then remove the fog light mounting screws and pull out the light (fig. 3).

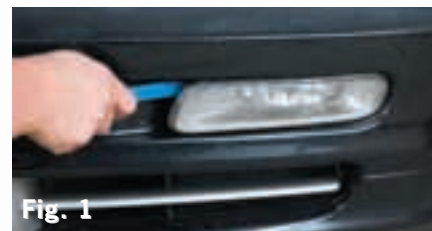
1 Using a non-marring pry-tool, pry out the inboard end of the light (fig. 1).

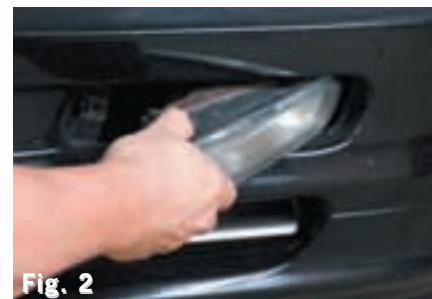
2 Pull light out and remove (fig. 2).
